SUBJECT: Interim Report for Downers Grove Groundwater Assessment,
Downers Grove, Illinois

AERIAL PHOTOGRAPHIC ANALYSIS OF
DOWNERS GROVE GROUNDWATER ASSESSMENT STUDY AREA

Du Page County, Illinois

Interim Report

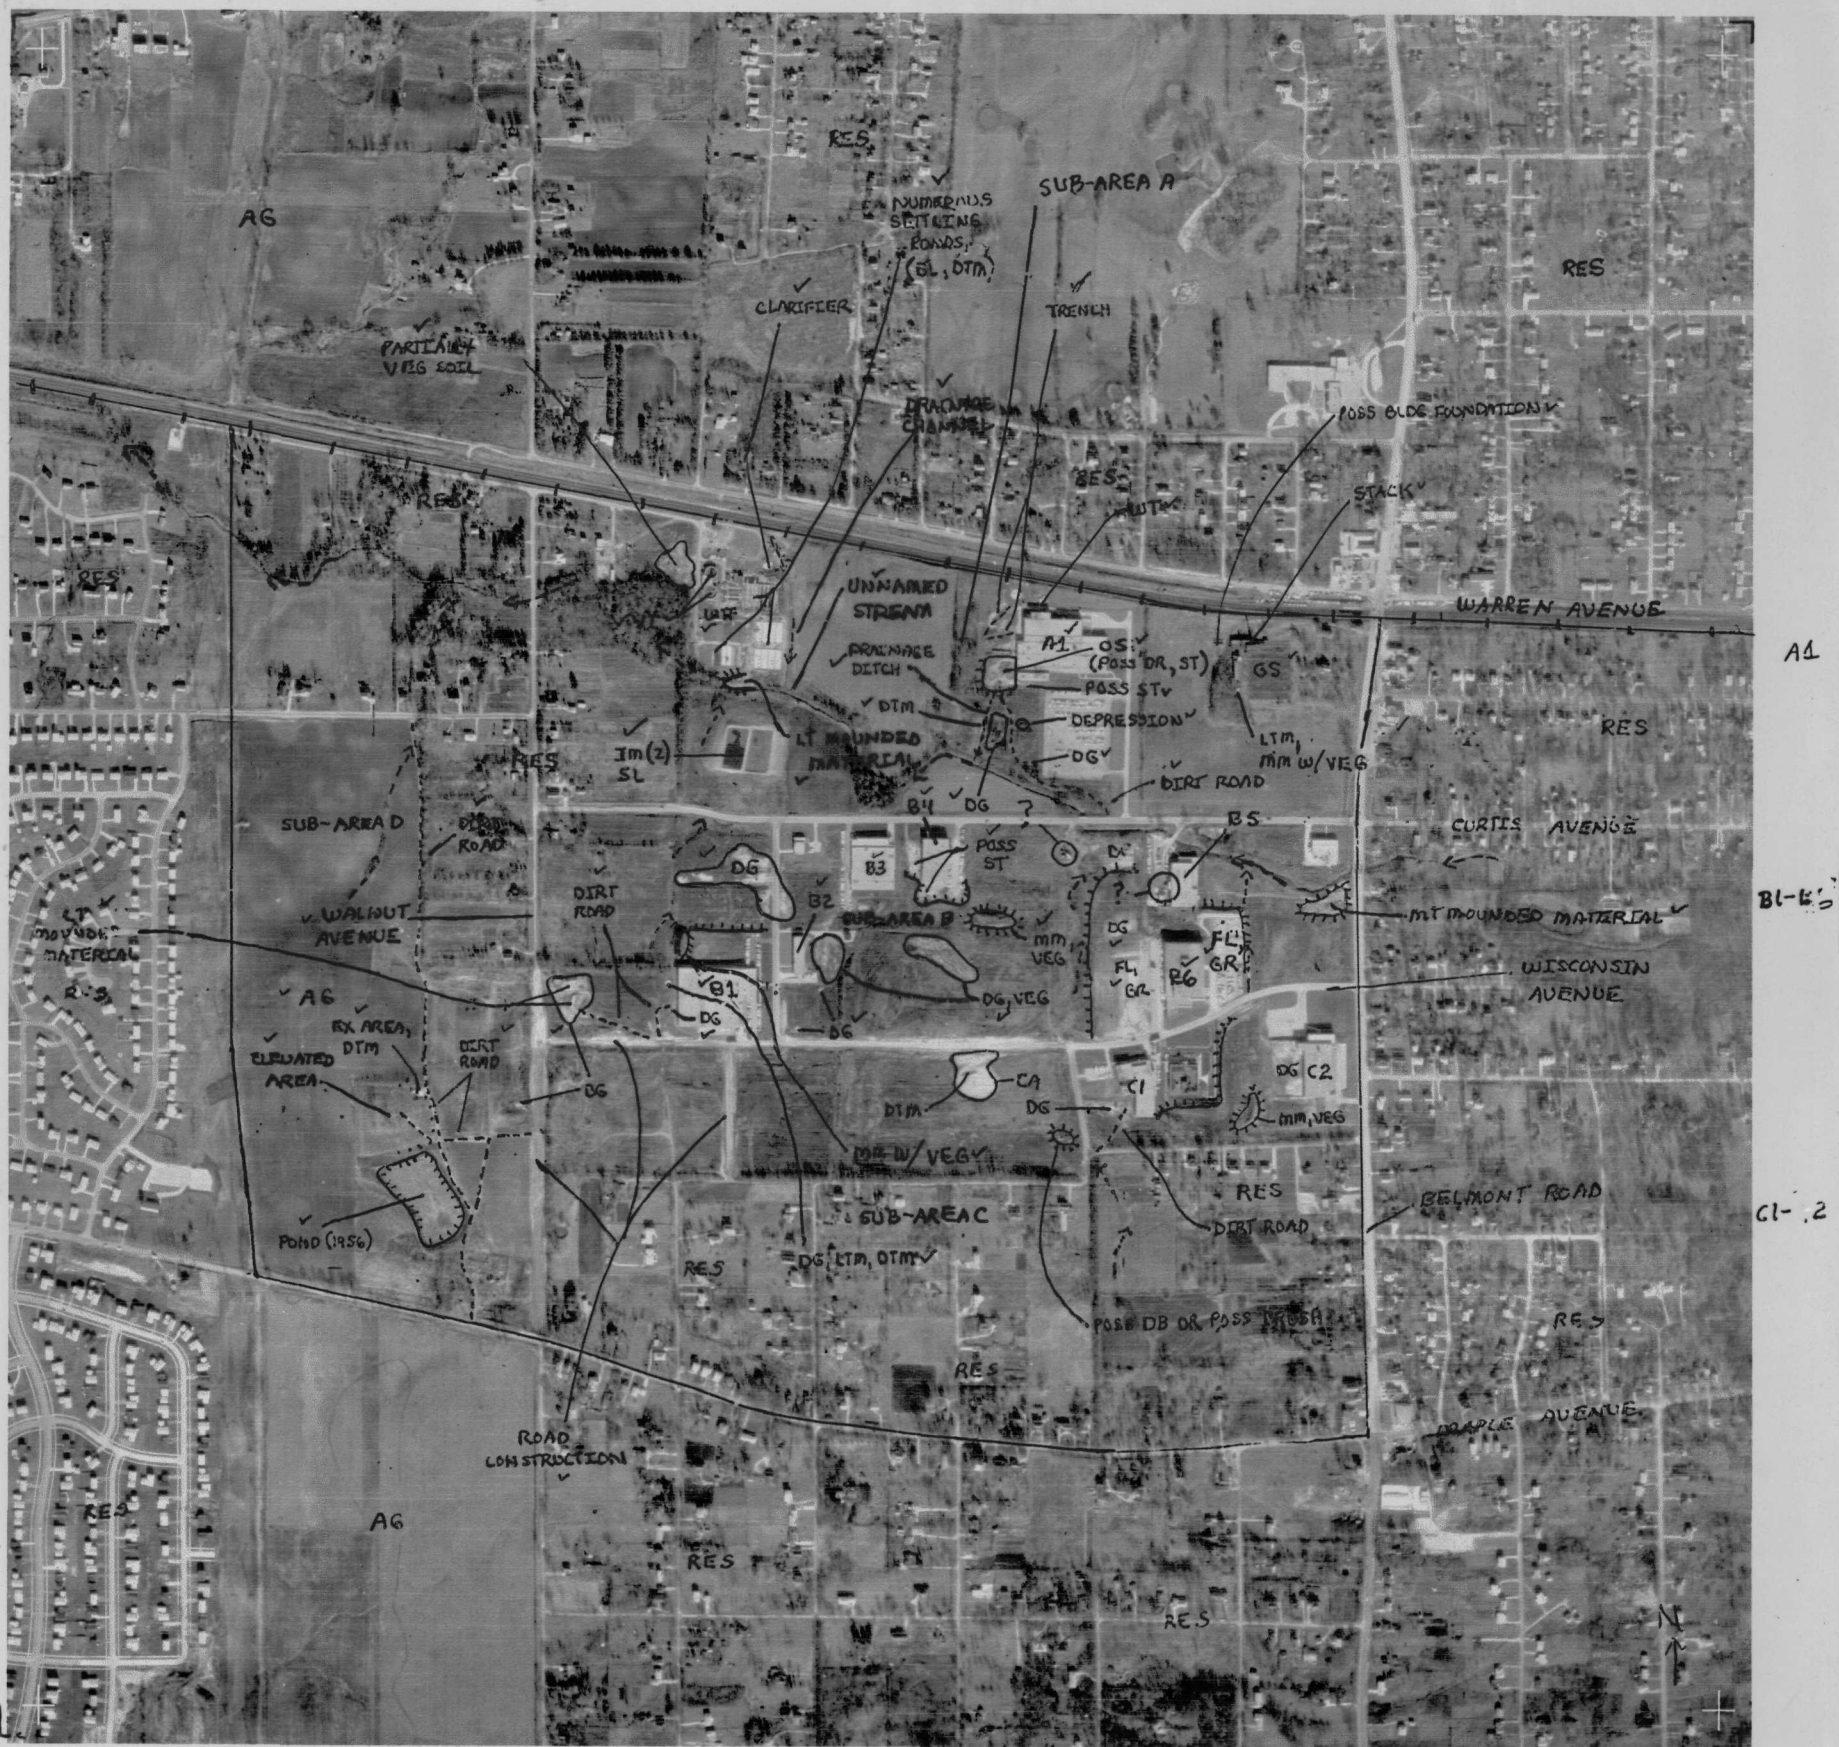
PLOTTERS GROVE 11/28/63 CHICAGO AREA SURVEY FRAME 392, 393, 394, 395
 EPI: 65:69, 65370, 67066, 67089
 M.S. 63400 SCALE 24K PHOTO SOLE

To the east is the large building (A1) and water tank. Alongside the southwestern corner of this building is an open storage area (OS) containing possible drums (DR) and stains (ST). A possible stain is also noted just to the east of the open storage area. To the north are two linear trenches, which are most likely man-made. A drainage ditch extends from the southern edge of the open storage area to the unnamed stream to the south. Dark-toned material visible near the center of the ditch may represent an area for the pooling of liquid. East of the drainage ditch is a swath of disturbed ground, and a dirt road with well-defined tire tracks extending southeast from the open storage area to Curtis Avenue. A second, smaller area of disturbed ground and a depression (possibly the location of soil excavation) are visible between the dirt road and an expansive parking area to the east (not annotated).

In the northeastern section of subarea A, the largest structure associated with the building complex visible in 1956 has been removed, leaving a large ground scar in its place. Only two small, rectangular-shaped structures (not annotated), as well as the smokestack and the possible building foundation, remain visible. Light-toned material, and mounded material (MM) covered with vegetation (VEG) are also noted.

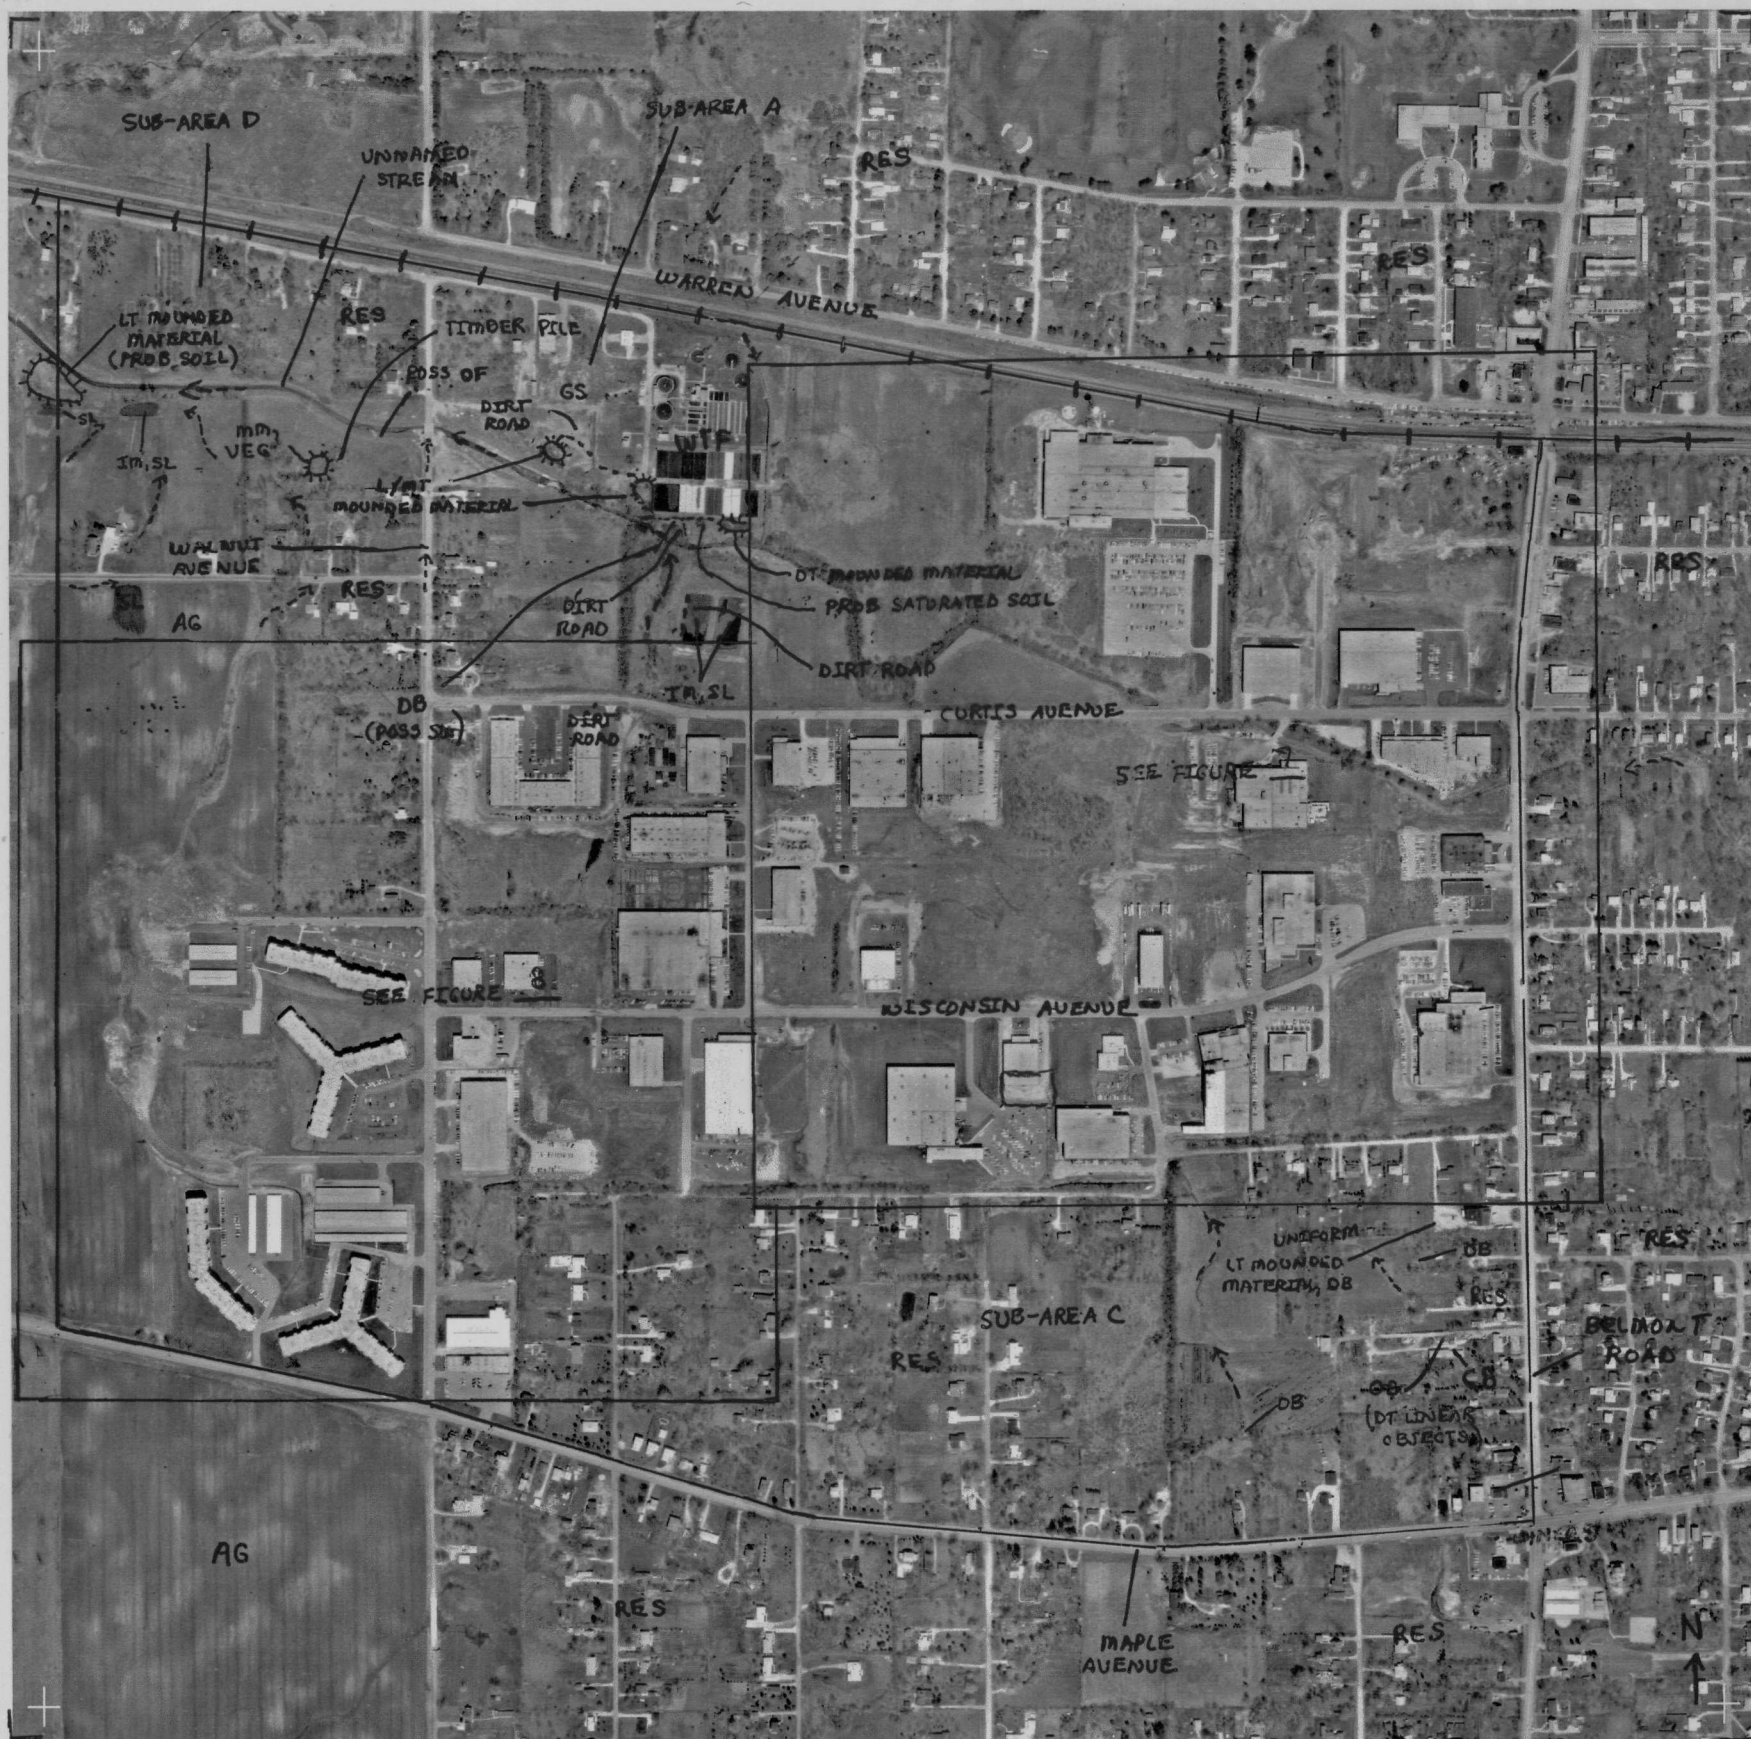
4/25/72 DOWNERS GROVE SIATELL FRAMES 676, 678, 680 MISSION SCALE PHOTO SCALE
 872 66866, 66867, 66868 12K

In the eastern portion of the subarea, an open storage area containing dark-toned linear objects is observed in the vicinity of building C8. North of this building are a small pile of debris and an area containing light-toned mounded material and debris. Additional debris is noted in a field (not annotated) west of building C8. No environmentally significant activity is observed near building C5 (gas station) at the northeast corner of Maple Avenue and Belmont Road or in the remaining residential areas in this subarea.

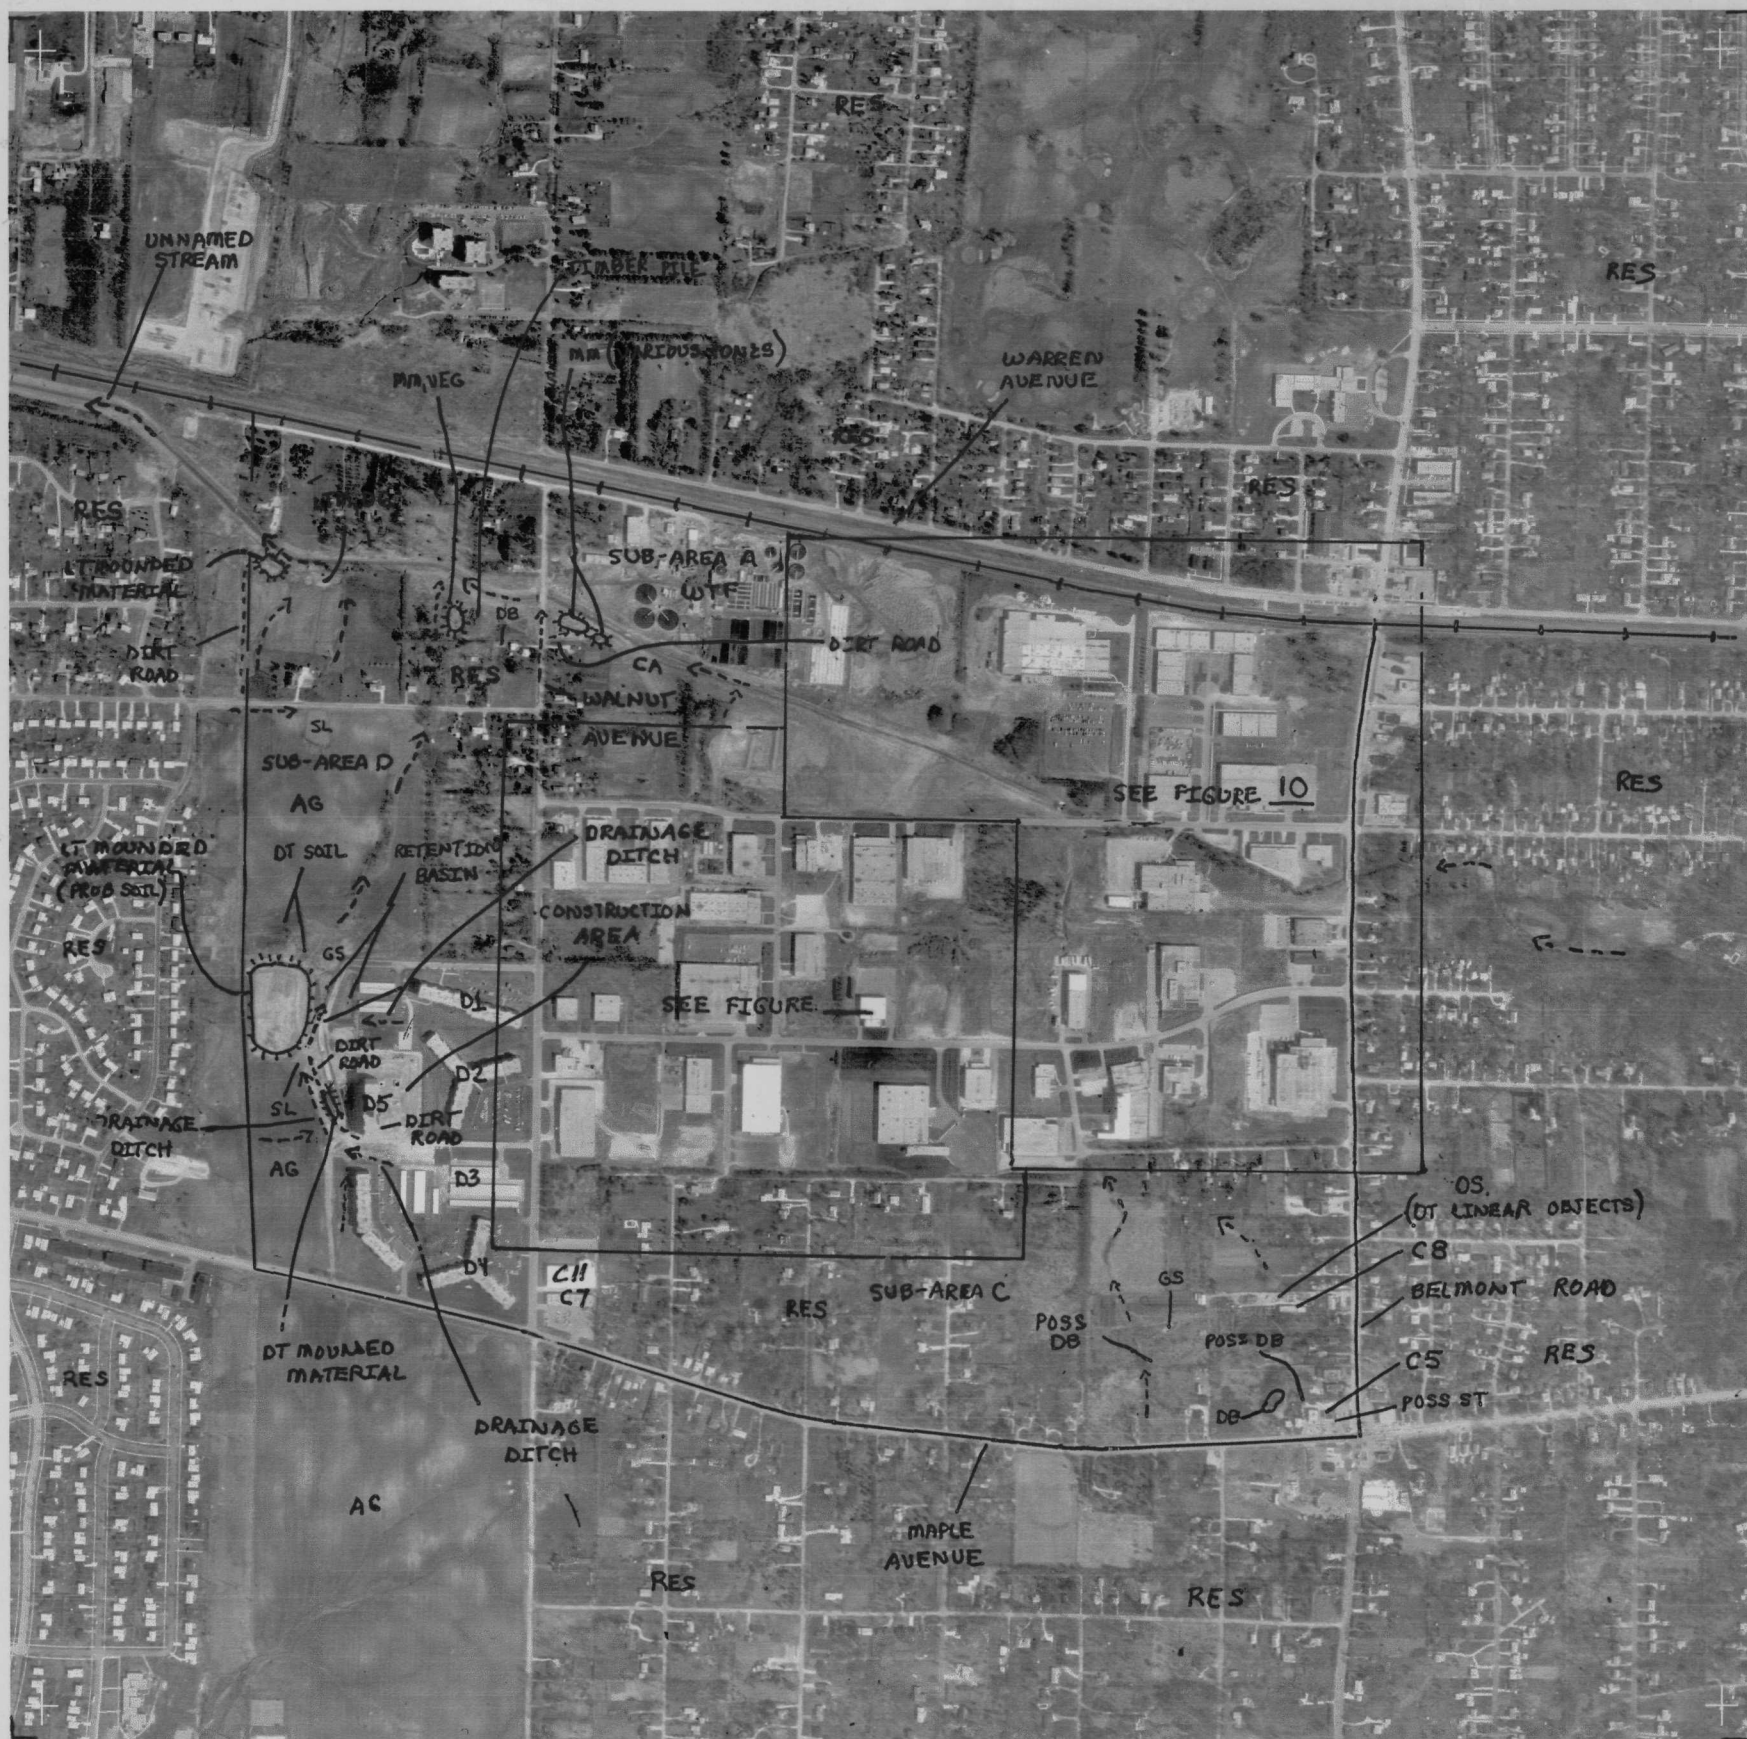
DOVENERS
GROVECHICAGO
AERIAL
SURVEYFRAMES
37, 38, 39
PIC 65375, 65376, 67086MISSION
75100SCALE
24K

In the eastern portion of the subarea, the open storage area containing dark-toned linear objects remains in the vicinity of building C8. To the south, in the vicinity of building C5 are a possible stain, several small piles of debris (annotated as one feature), and a small pile of possible debris. In a field (not annotated) to the northwest, possible debris and a ground scar are noted. No environmentally significant activity is observed near building C7 or the remaining portions of the residential area.

In the southern section of this subarea, numerous large buildings and the building complex (D1 through D4) observed in 1972 remain visible. Additional structures (not all annotated) are also observed, such as new building D5, which is part of a larger construction area that was built on the former elevated area seen on past images. This construction site has been graded and it is likely that the materials removed from the site have been deposited to the northwest, forming a conspicuous mound of uniform and finely textured

light-toned material (probable soil). No vegetation is visible on the surface of the mound, suggesting recent deposition. The mound is accessed via a dirt road from the southeast. A second mound, composed of dark-toned material, is noted along this access road. East of the light-toned mound are two retention basins. Materials from the excavation of these basins might also have been deposited on the mound. Ground scars are visible to the northeast.

Well-defined drainage ditches are noted throughout the complex of buildings, and it appears runoff is to be channeled into the retention basins. No liquid is present in the basins, although a well-defined drainage ditch does connect an area of standing liquid to the western retention basin southeast of the light-toned mound.

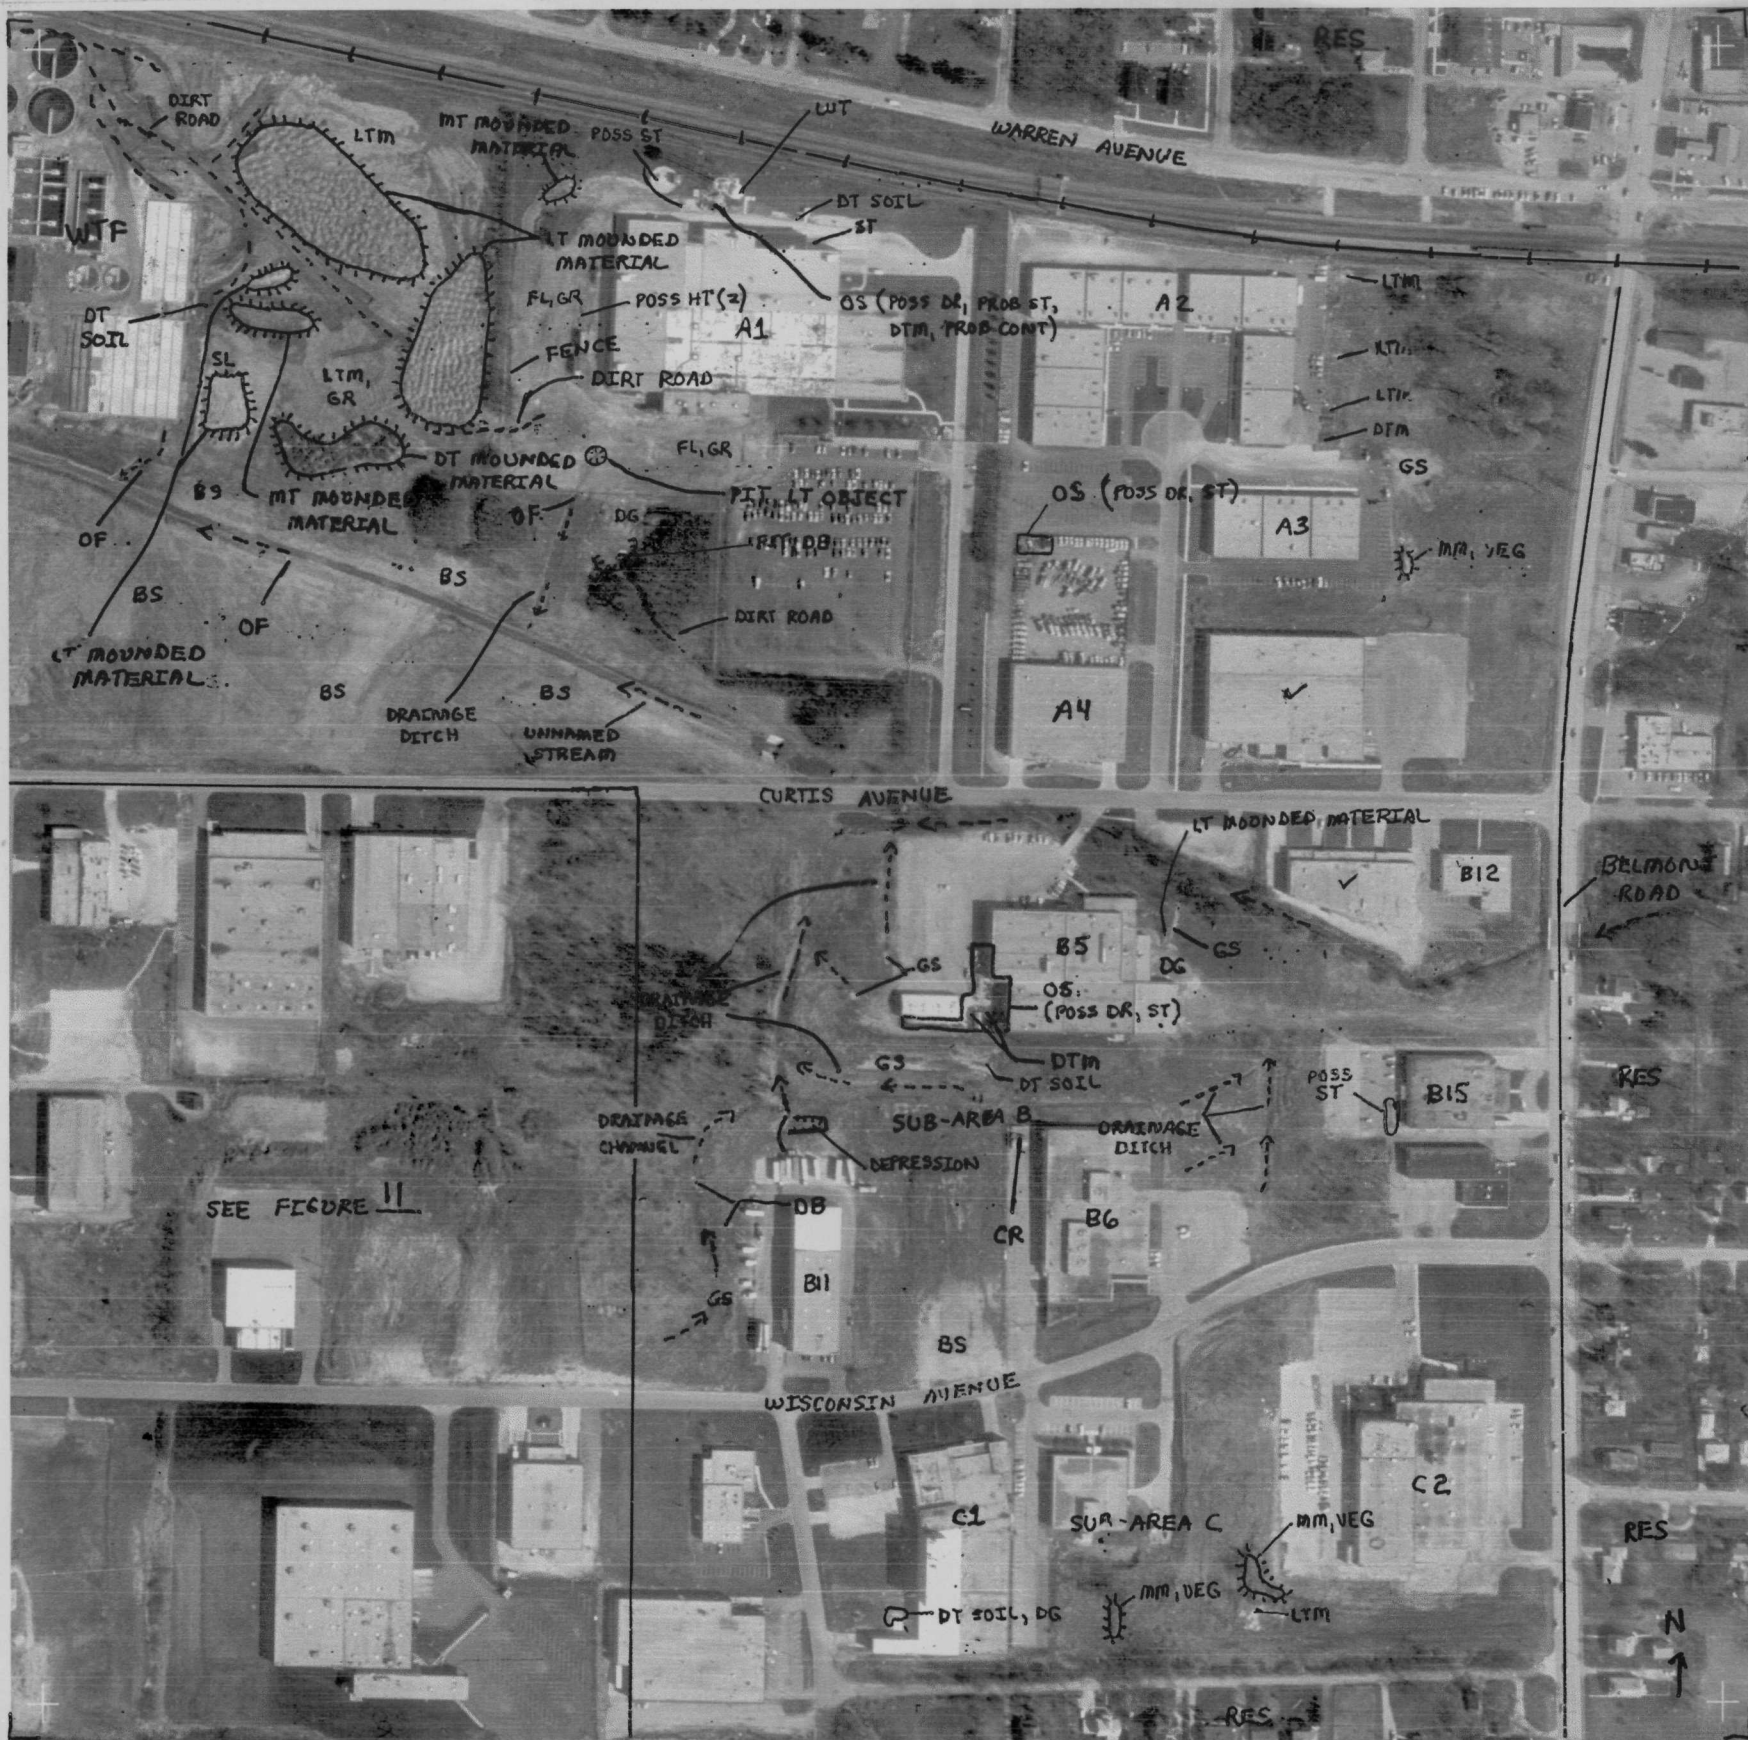
is visible, and a dirt road links building A1 to the mounded material to the west. Also to the southwest of the building is a pit containing a light-toned object, an outfall, and the drainage ditch which carries liquid south into the channelized section of the unnamed stream. East of the drainage ditch are disturbed ground and a pit where more debris is noted. The remnants of the dirt road which in 1972, connected this area to the parking lot (not annotated) to the east, remains discernible through the small patch of trees (not annotated); although, no longer can it be connected to the parking lot. Due to the channelization process, bare soil, scarred with striations from earth-moving equipment, is noted north and south of the stream.

East of building A1, in the northeast section of subarea A, two new buildings (A2 and A3) are visible. Three small piles of light-toned material, and dark-toned material (possible linear objects) are located east of building A2. A ground scar, and mounded material possibly covered with sparse vegetation are located east of building A3. An open storage area containing possible drums and stains is located in the northwest part of the parking lot (not annotated) associated with building A4, a structure that was present in the 1972 image, but was not annotated.

In the northern section of this portion of the subarea, one open storage area remains visible along the west side of building B5. Possible drums, stains, and dark-toned material are observed within it. Small ground scars are noted nearby and two drainage ditches, which originate near the open storage area, channel surface runoff into the unnamed stream to the north. A second, partially fenced open storage area that was noted on the east side of this building in 1972 is no longer visible. A building addition (not annotated) has been constructed in this location since that time. A well-defined, linear ground scar starts at the north side of this new building addition and terminates near the stream to the north. The disturbed ground and the small pile of light-toned mounded material adjacent to the scar suggest this is the location of a buried pipeline. To the east, near the intersection of Curtis Avenue and Belmont Road, no activity of environmental significance is noted near building B12.

Southwest of building B5, two small piles of debris and a ground scar are observed near a natural drainage channel west of building B11. To the north of the building, a deep, well-defined drainage ditch, originating at the parking lot (not annotated) north of the building, appears to have eroded away the western section of the depression seen in 1972. Along Wisconsin Avenue, east of building B11, the patch of bare soil remains evident. The elevation of this area may be slightly lower than the surrounding area; thus, allowing liquid to pool and inhibit the growth of vegetation. Stacked crates remain visible near building B6. Northeast of this building are several drainage ditches. Possible stains are noted to the east along the west side of building B15 (not annotated on previous images) located on Belmont Avenue.

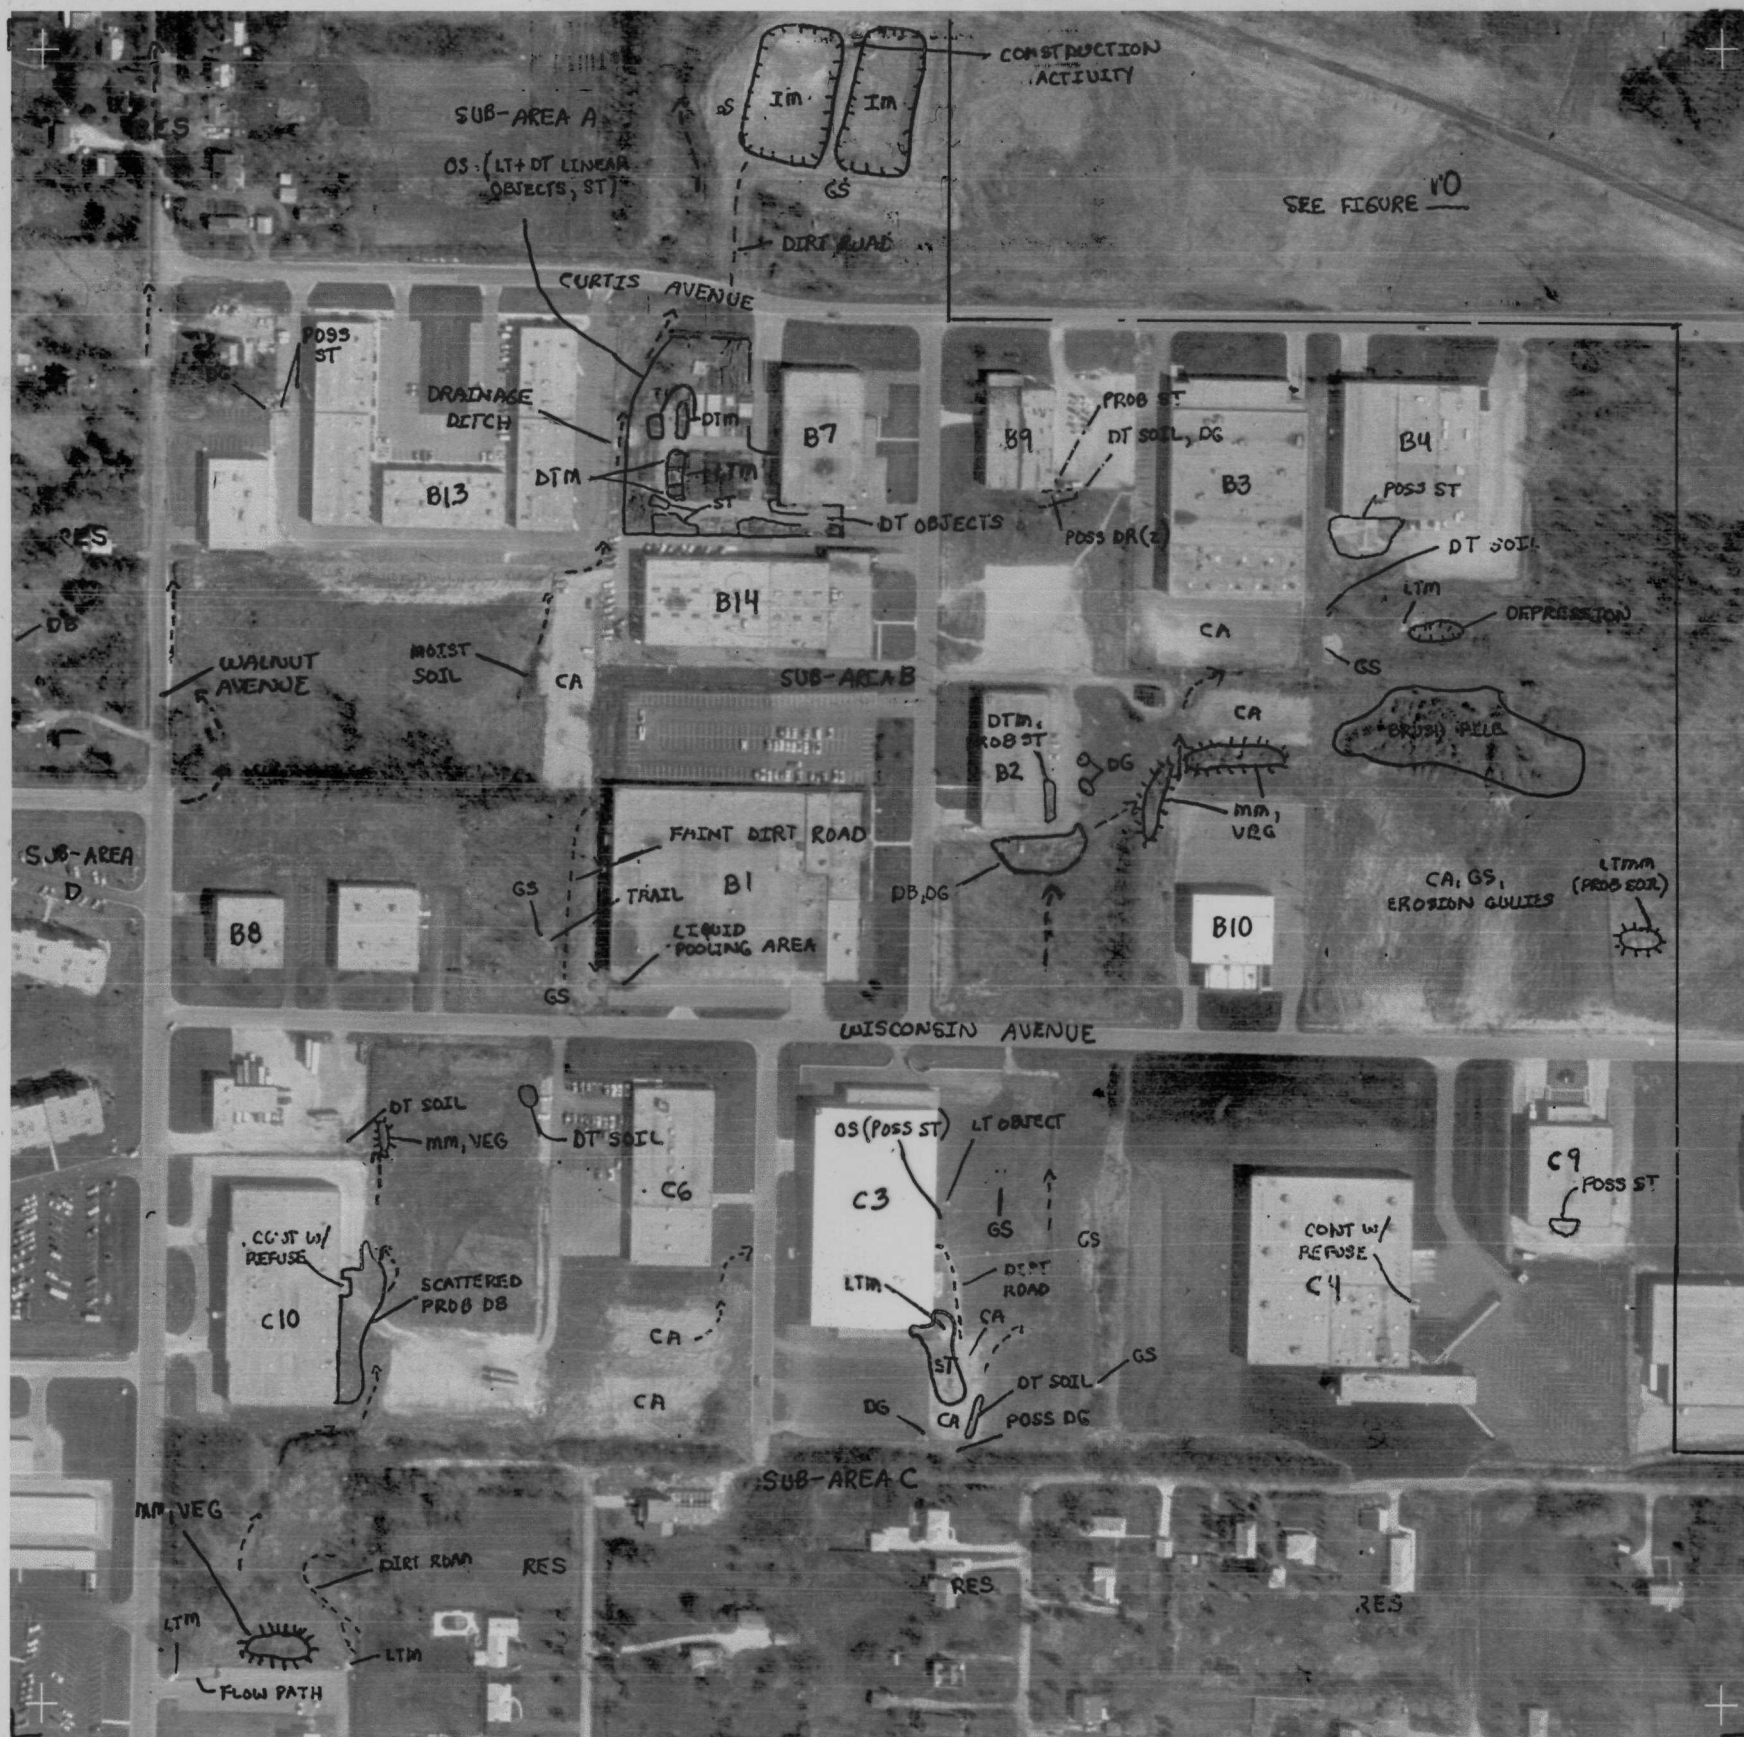
DOWNERS
GROVE

In the eastern section of this subarea, southeast of the intersection of Curtis Avenue and an unnamed street, two possible drums, probable staining, dark-toned soil, and disturbed ground are observed beside building B9 (not previously annotated). To the east a cleared area is located south of building B3, to the east possible stained ground is noted south of building B4. In addition, dark-toned soil, a ground scar, light-toned material, and a depression are evident south of building B4. The ground surface near the depression is covered with vegetation, suggesting activity immediately south of building B4 has decreased when compared to previous images.

To the southwest are building B2 and B10. Adjacent to building B2 are dark-toned material and probable staining. An open storage area was identified at this location in 1972. In the field (not annotated) south of this building is scattered debris and disturbed ground. Additional areas of disturbed ground is noted in the field (not annotated) east of this building. To the east and north of building B10, are two mounds covered with vegetation are noted as is a rectangular-shaped cleared area. Further east is a prominent brush pile, probably composed of the vegetation cleared from the field (not annotated) to the south, near Wisconsin Avenue. Ground scars from the use of earth-moving equipment, and numerous erosion gullies are visible on the surface of the cleared area. This location is likely being readied for future development. Immediately east of the cleared area is uniform, light-toned mounded material that is probably composed of soil.

Southeast of the intersection of Wisconsin and Walnut avenues, dark-toned soil and mounded material covered with vegetation are noted northeast of building C10. Immediately east of this building is a long area of scattered probable debris and a container with refuse. In the field (not annotated) south of building C10 is mounded material covered with vegetation. Both east and west of this mound, on the fringe of a parking lot (not annotated), small piles of light-toned material are noted (the easternmost pile was visible in 1972). A dirt road extends north from the eastern pile of light-toned material into the field, where it terminates at a stand of trees (not annotated). In the parking area, a flow path appears to be originate at an automobile (not annotated). To the northeast, between buildings C10 and C6, dark-toned soil is

observed. A depression and moist soil was observed at this location on previous images; however, a depression cannot be confirmed on this image. South of building C6, the ground surface has been cleared of vegetation, likely in response to future development.

To the east, on the east side of building B3, a light-toned object is noted, as is a small, enclosed open storage area with a possibly stained ground surface. No other features can be discerned in this open storage area where, in 1972, four possible drums and containers were observed. A dirt road connects the open storage area to the cleared area southeast of the building. Stained ground remains on the cleared area, but it is not quite as heavy or widespread as the staining observed in 1972. The well-defined dirt road (identified as a trail in 1972) suggests that materials continue to be transported from near the open storage area and deposited in the cleared area. Also in the vicinity are dark-toned soil, disturbed ground, possible disturbed ground, and ground scars. A linear-shaped ground scar is noted at the location of a drainage ditch observed in 1972.
